FACILITY COMPLIANCE INSPECTION REPORT

Division of Waste Management Solid Waste Section

Date of Site Inspection: June 28, 2013

Yadkin County Solid Waste Transfer Facility
 1149 Landfill Road
 Yadkinville, North Carolina 27055

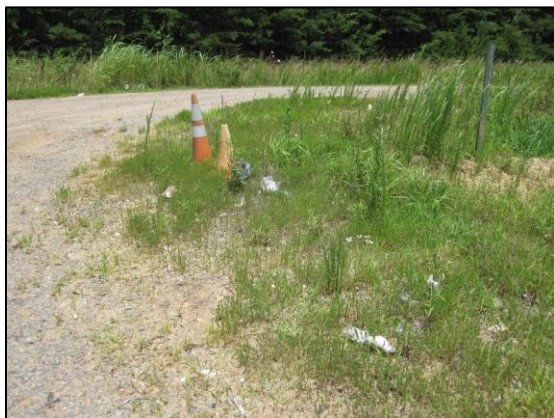
During the inspection, windblown material was observed along the eastern portion of the access area at the entrance to the transfer facility, along the perimeter of the access road leading around the back of the facility, and within the rip rap area located at the southeast corner of the facility. Therefore, Yadkin County is in violation of 15A NCAC 13B .0402(7).

View of windblown waste on east side of entrance to transfer facility.

To achieve compliance, all windblown waste surrounding the transfer station must be picked up and returned to the transfer facility within 10 days of issuance of this report.

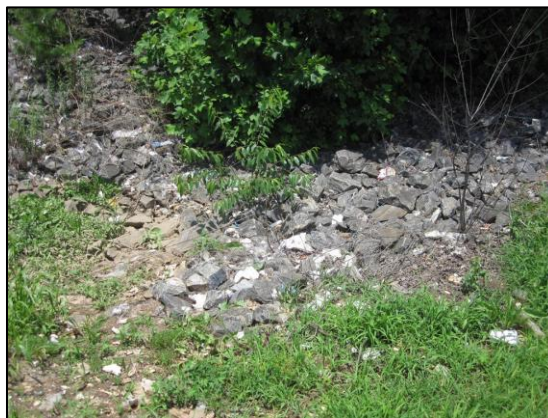
View of windblown waste at rip rap area at southeast corner of transfer facility.

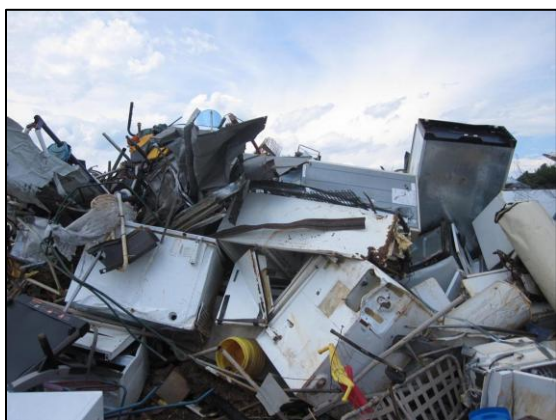
During previous inspections, the “designated area” for white goods was a covered concrete pad near the recycling area. Ms. Jester explained that the white goods area had been relocated since the last inspection to the concrete pad where the kennel was once located. However, during this inspection, all white goods containing chlorofluorocarbons (CFCs) were observed deposited on the metal pile in various degrees of damage.

Yadkin County is in violation of 15A NCAC 13B .0203(d), .0402(1) and Operating Condition #22 of the Permit to Operate in that the facility was not providing for the proper removal of CFCs as all white goods containing CFCs were deposited on the metal pile in various degrees of damage, and white goods containing CFCs were not being stored in the designated area as detailed in the approved Operation Plan.

View of refrigerators deposited on metal pile prior to removal of CFCs.

To achieve compliance, Yadkin County must relocate all white goods to the proper, designated area and must be placed in an upright condition within 10 days of issuance of this report as to maintain the integrity of the appliances until CFCs have been properly removed.

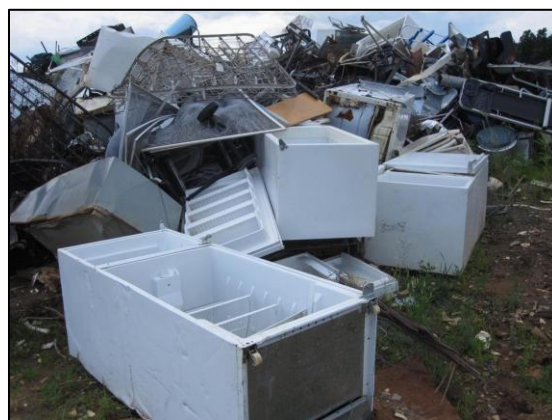
View of refrigerators deposited at metal pile prior to removal of CFCs.

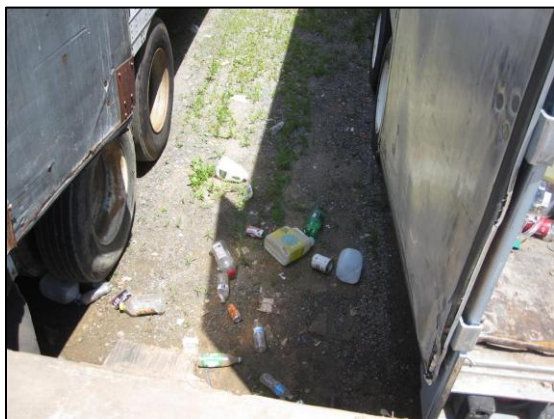
Yadkin County is in violation of General Condition #17 in that a windblown waste was observed on the ground surrounding the trailers located on the east side of the recycling area. This material consisted primarily of plastic bottles and appeared to originate from the storage bays for recyclables.

View of waste on ground east of recycling area.

To achieve compliance, all windblown waste as a result of recycling activities must be picked up and returned to the designated disposal area within 10 days of issuance of this report. Steps must also be taken to prevent future incidents of recyclables being deposited by wind outside of the designated recycling area creating a nuisance. Action can include, but not be limited to, replacing the retaining nets at the entrance to each recycling bay.

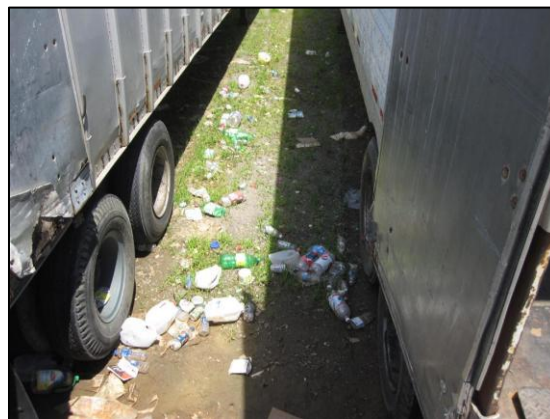
Additional view of waste on ground from recycling area.
